Connector: **C0386**

Harness: **TAILGATE UPPER HARNESS**

Description: **Tailgate harness to main harness**

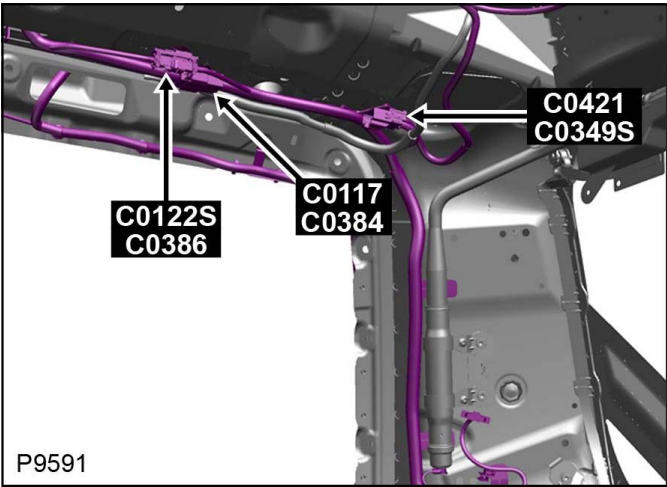
**CONNECTOR HOUSING NOT SERVICEABLE**

Cavities: **4WY**

Location: **Rear of headlining - LH side**

| CAV | CSA | COL | CCT | DESTN |
| SCR | 0.5D | SCR | 784 | C2788 |
| 1 | 0.13D | BU | 784 | C2788 |
| 2 | 0.13D | OG | 784 | C2788 |
| 3 | 0.13D | GN | 784 | C2788 |
| 4 | 0.13D | BN | 784 | C2788 |
