HYUNDAI MOTOR COMPANY  
DAEWOO TAPKUDONG  
PLANT 1

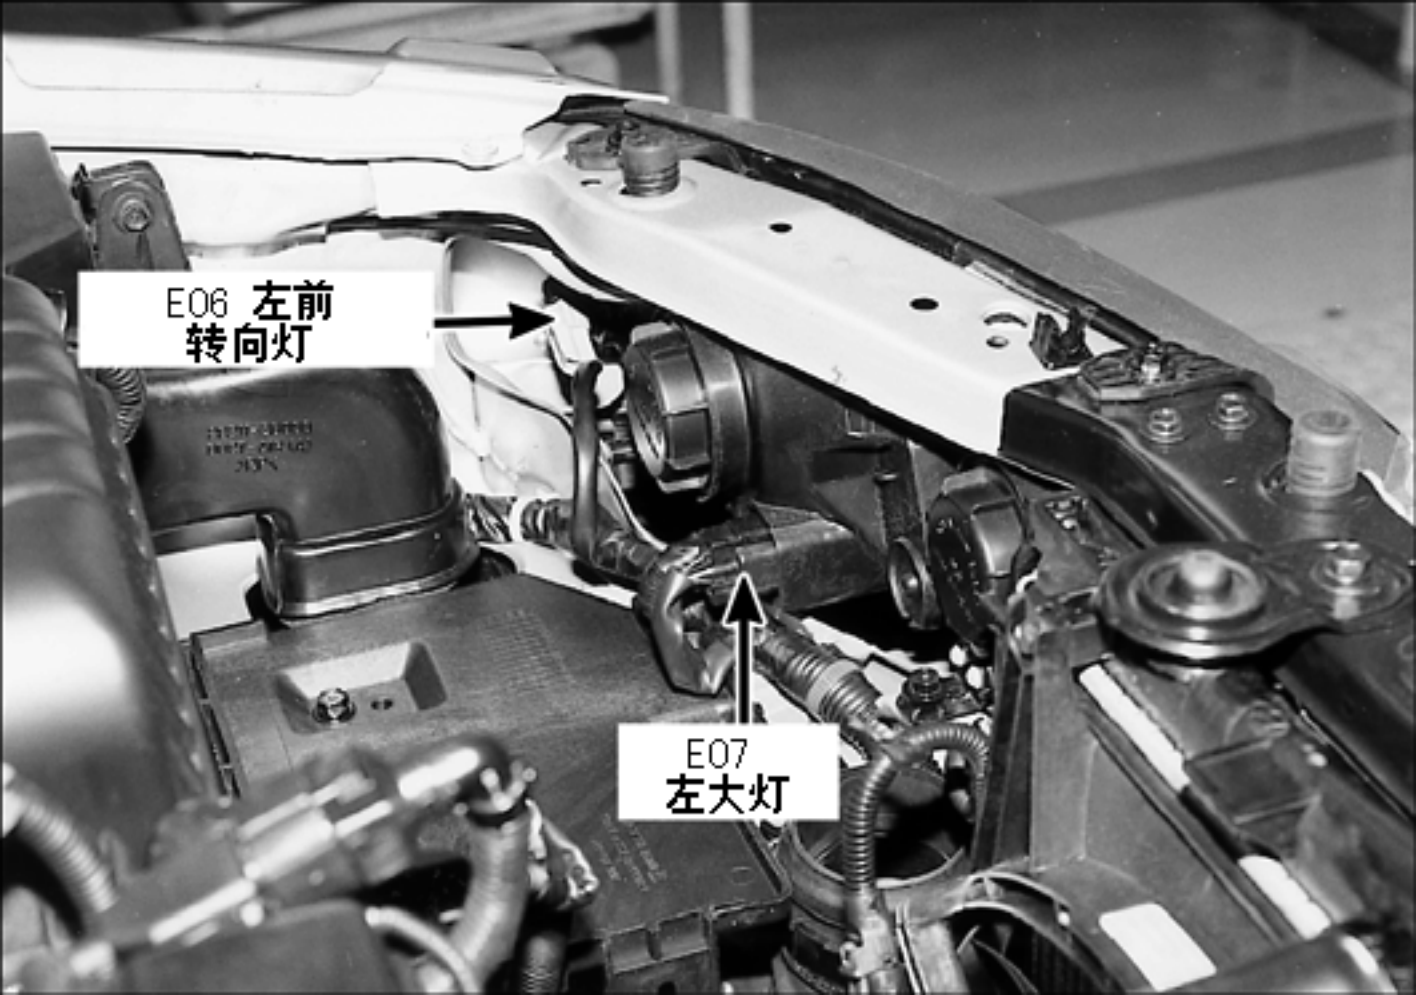
E02 左前轮速  
传感器

E06 左前  
转向灯

E07  
左大灯

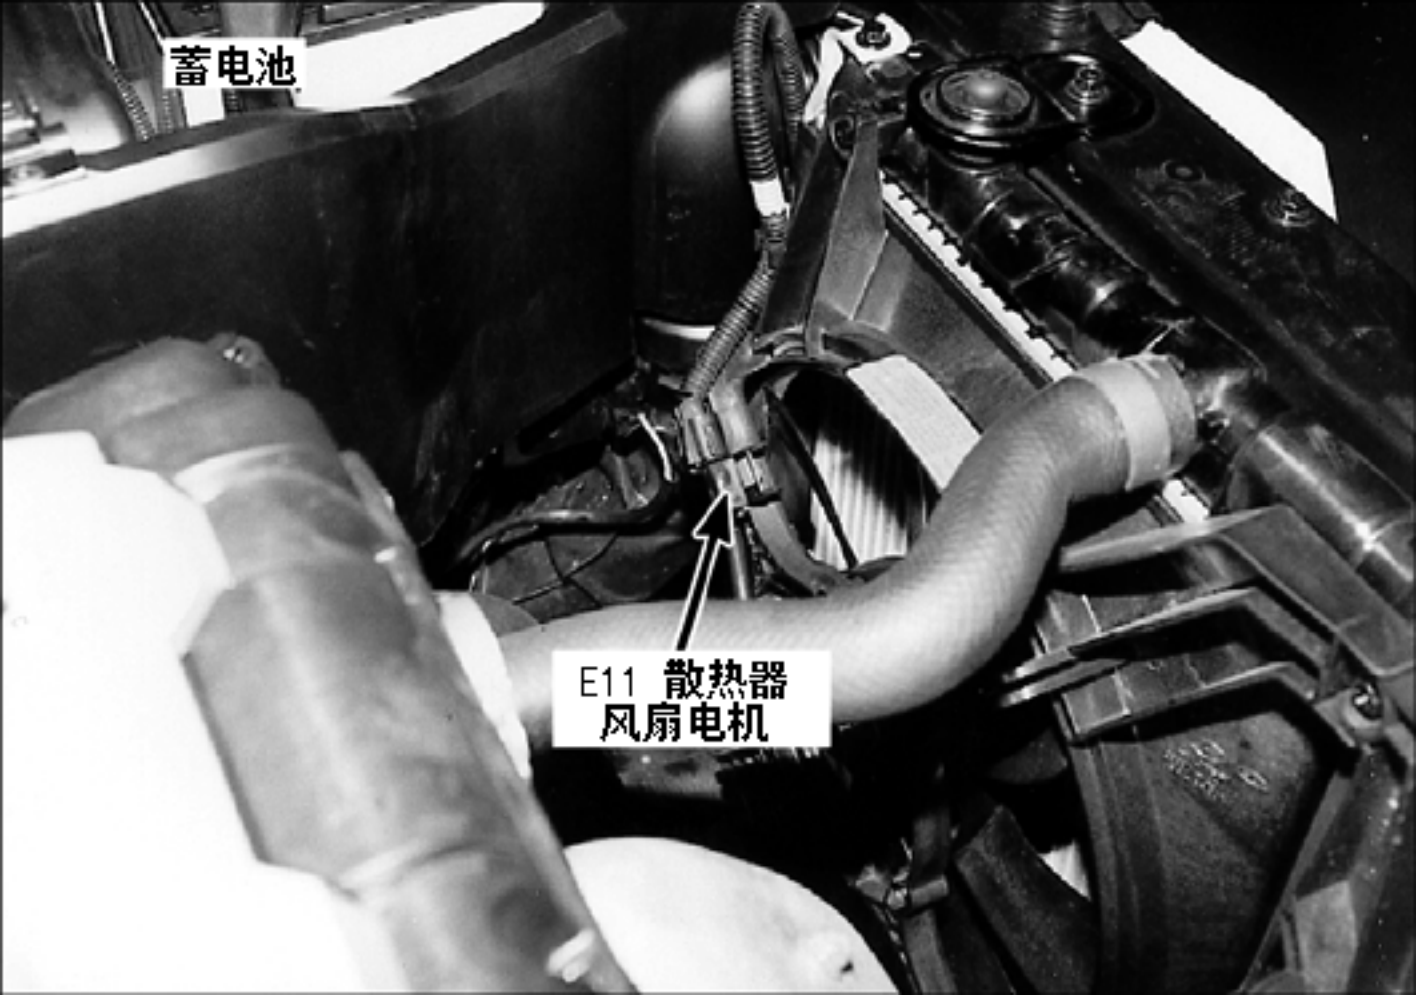
E10 (左)  
E24 (右)  
大灯水平  
调整执行器

E11 散热器  
风扇电机

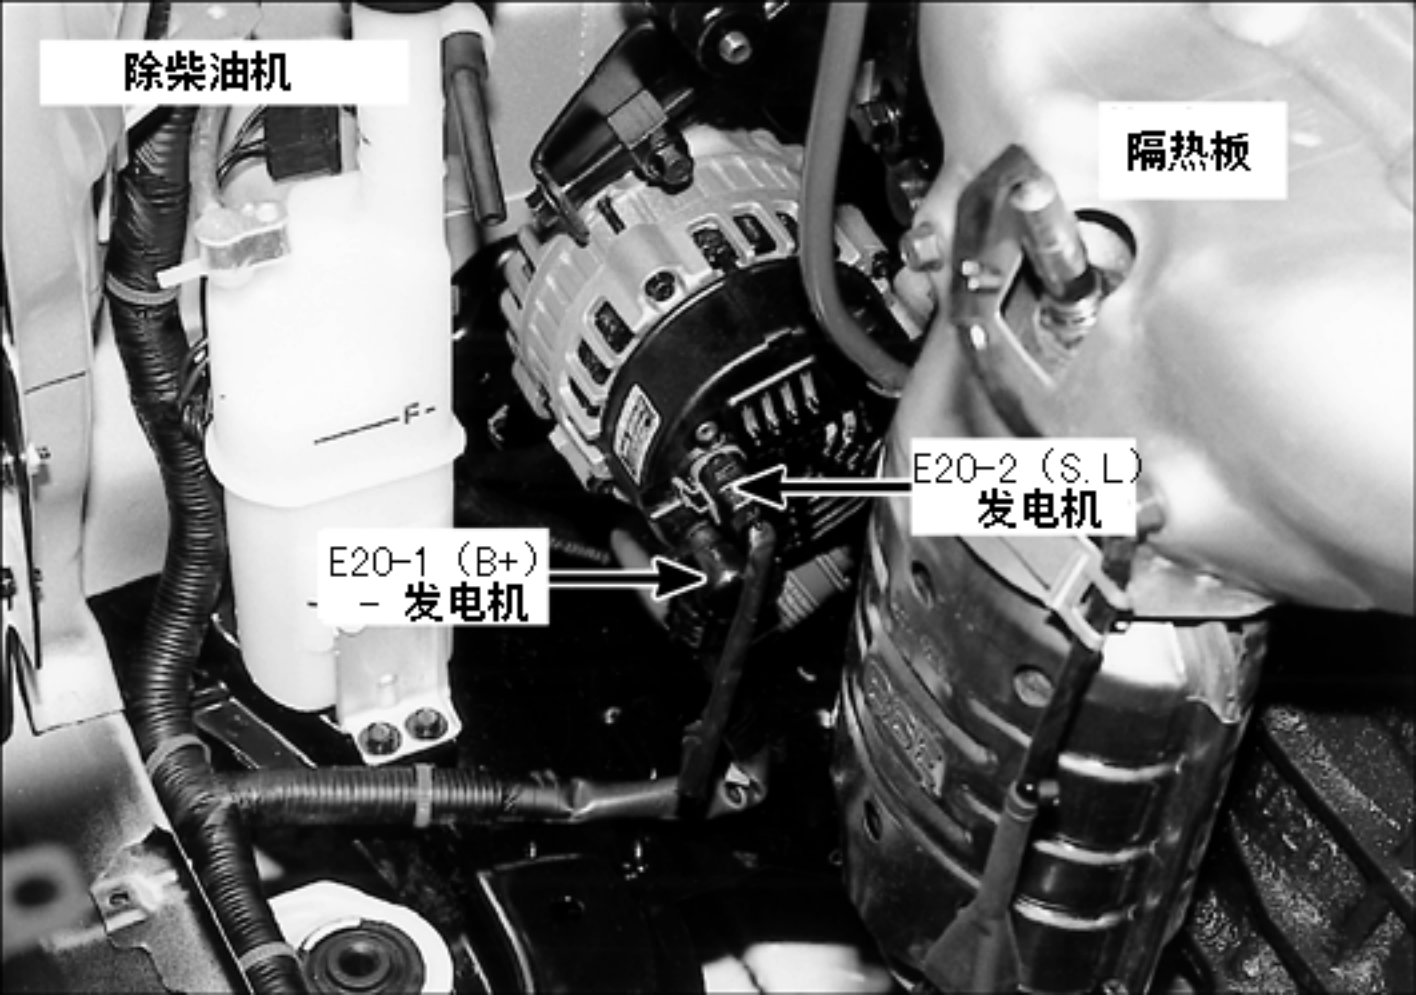
E20-2 (S.L)  
发电机

E20-1 (B+)  
- 发电机

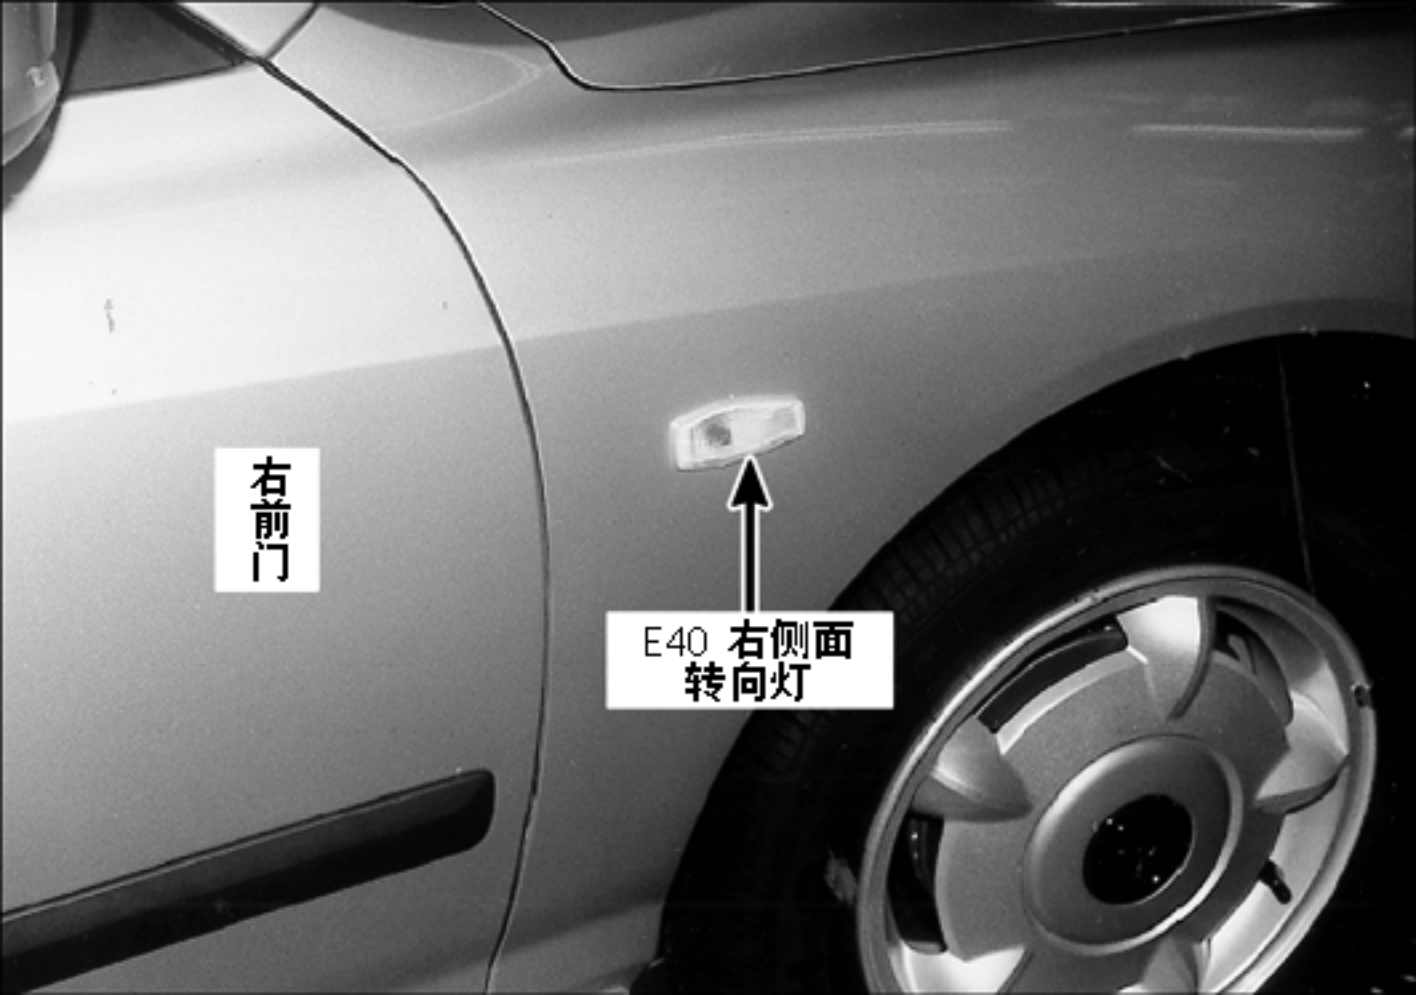
E39  
右前轮速传感器

E40 右侧面  
转向灯

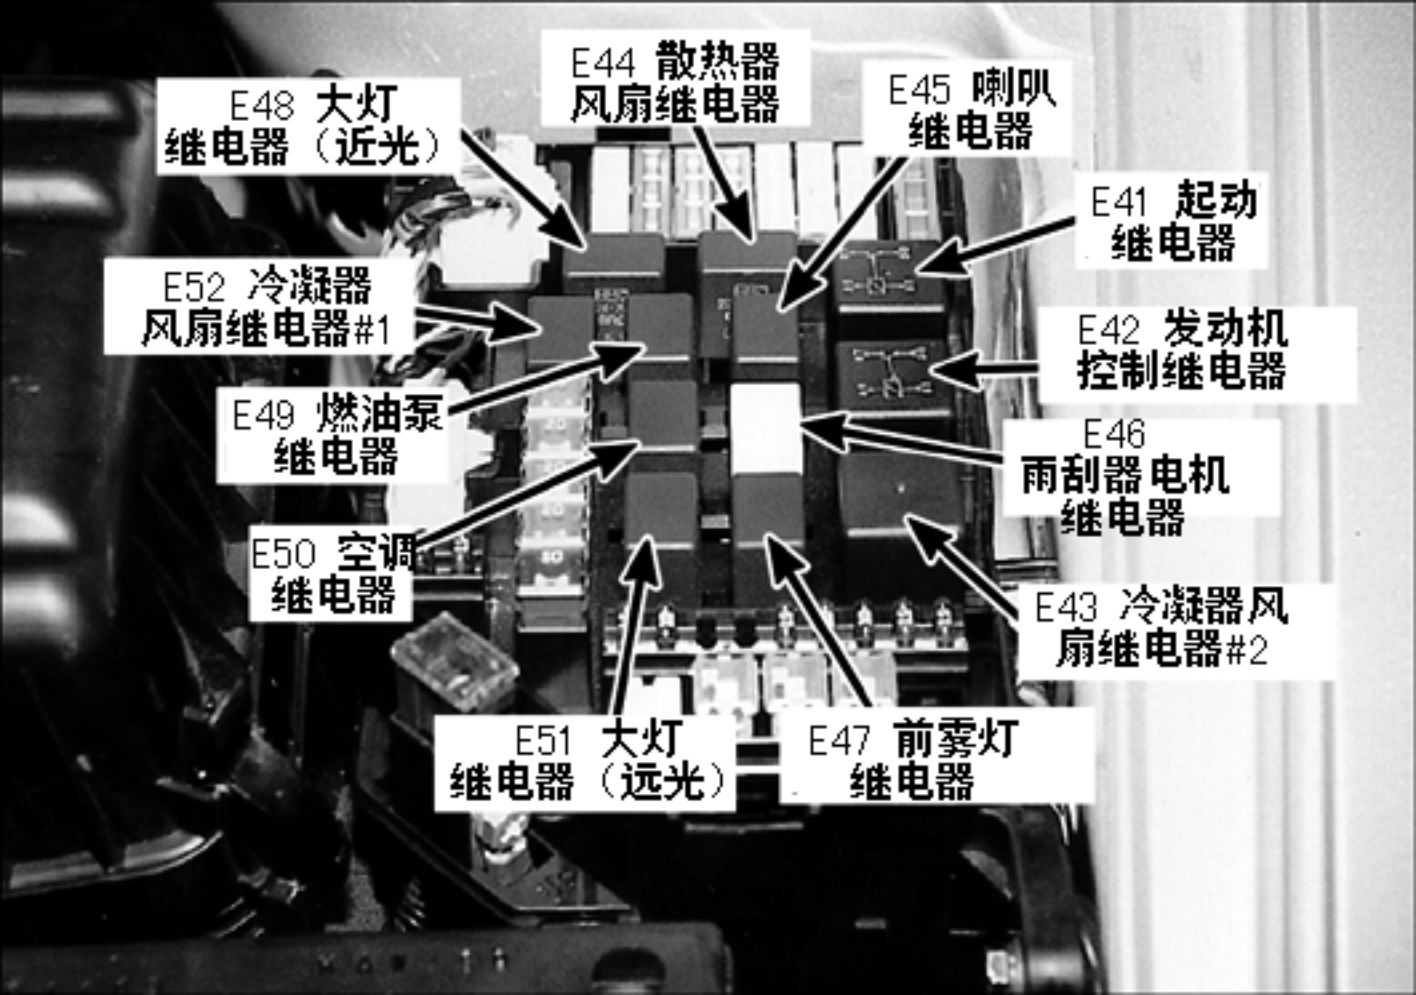
E48 大灯  
继电器 (近光)

E44 散热器  
风扇继电器

E45 喇叭  
继电器

E41 起动  
继电器

E52 冷凝器  
风扇继电器#1

E42 发动机  
控制继电器

E49 燃油泵  
继电器

E46 雨刮器电机  
继电器

E50 空调  
继电器

E43 冷凝器风  
扇继电器#2

E51 大灯  
继电器 (远光)

E47 前雾灯  
继电器

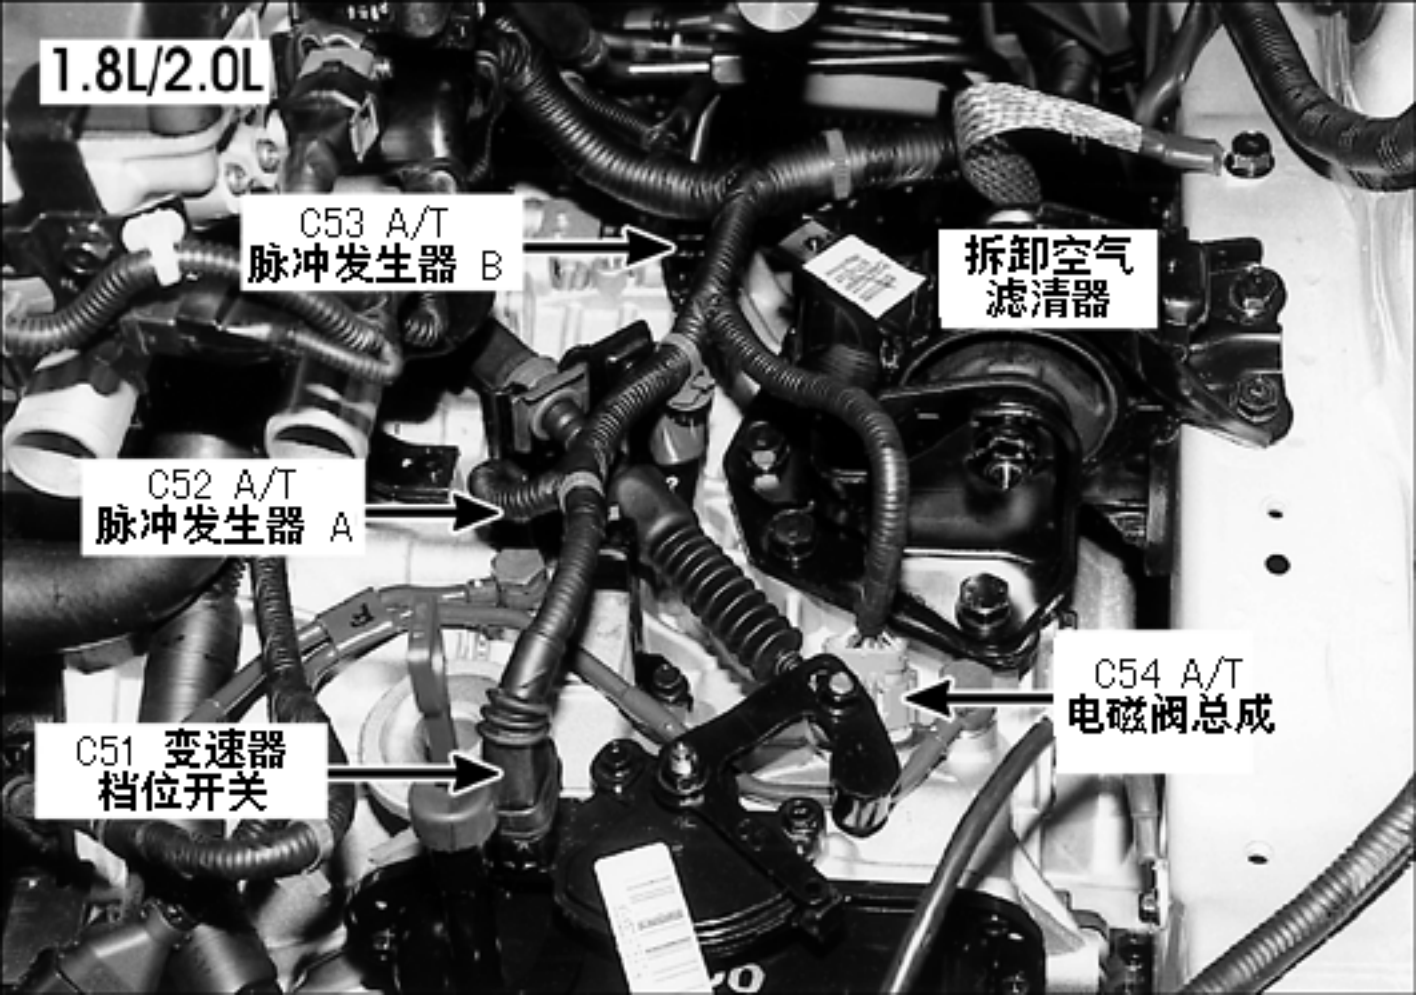
C53 A/T  
脉冲发生器 B

C52 A/T  
脉冲发生器 A

C51 变速器  
档位开关

C54 A/T  
电磁阀总成

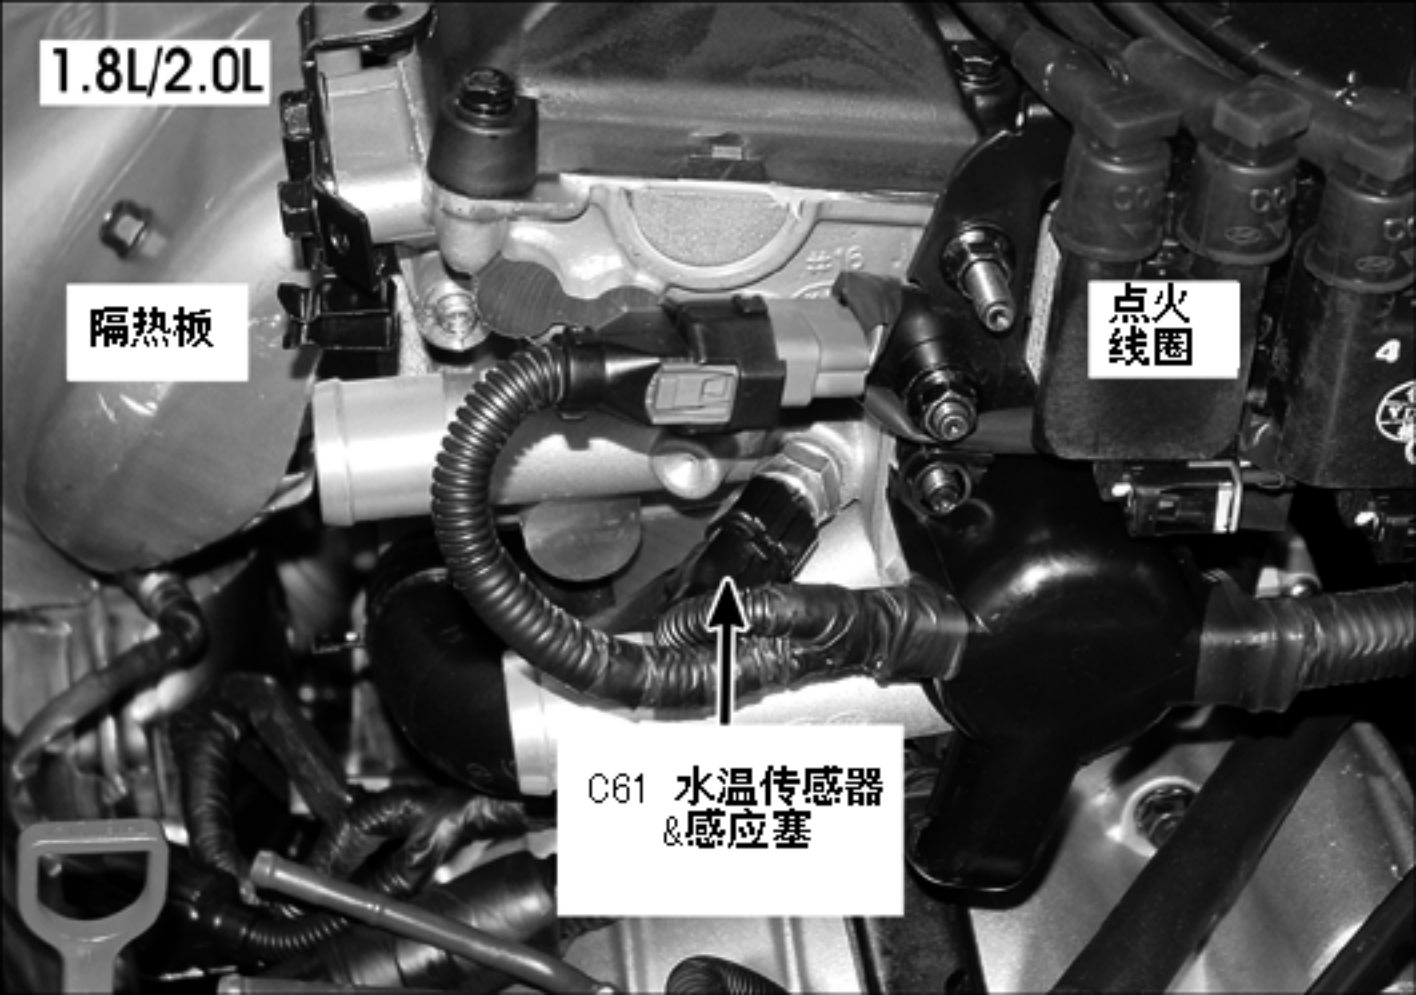
隔热板

点火线圈

C61 水温传感器  
& 感应塞

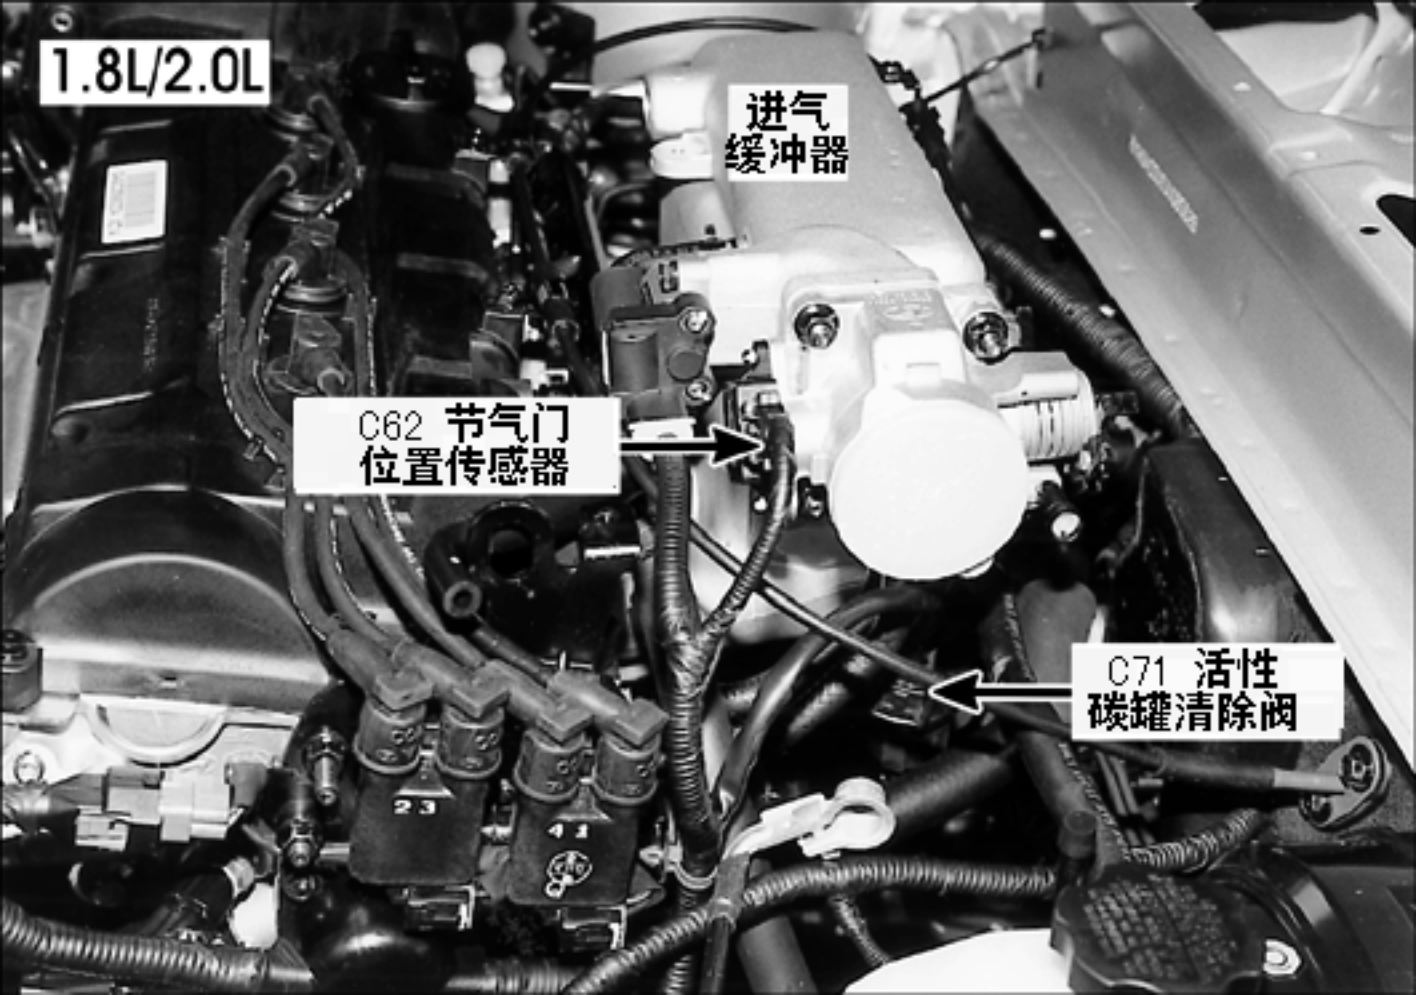
进气  
缓冲器

C62 节气门  
位置传感器

C71 活性  
碳罐清除阀

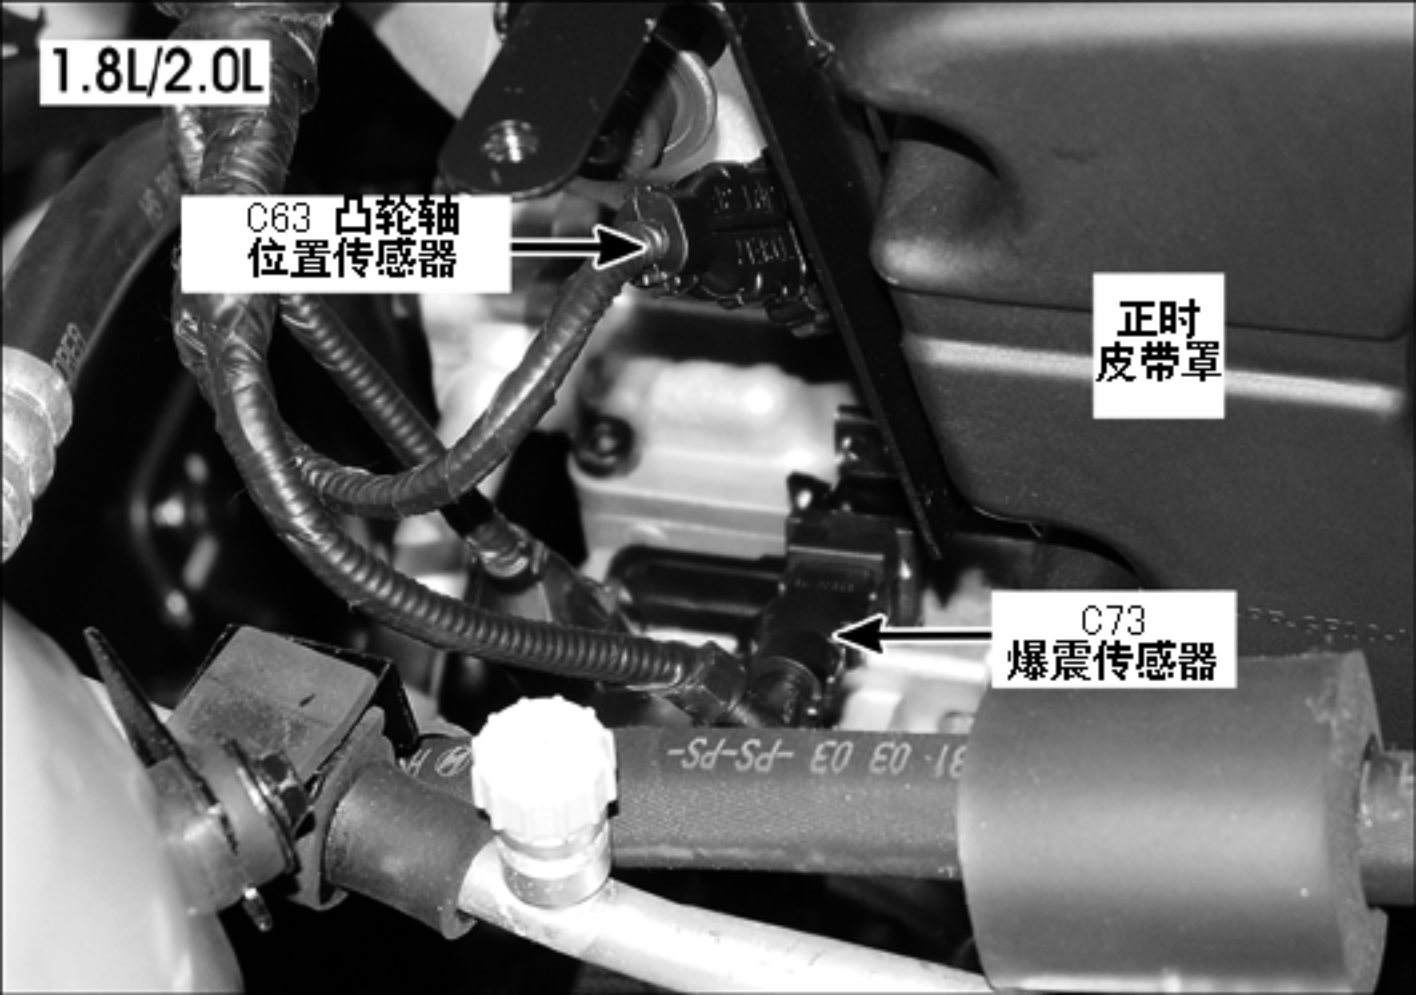
C63 凸轮轴  
位置传感器

正时  
皮带罩

C73  
爆震传感器

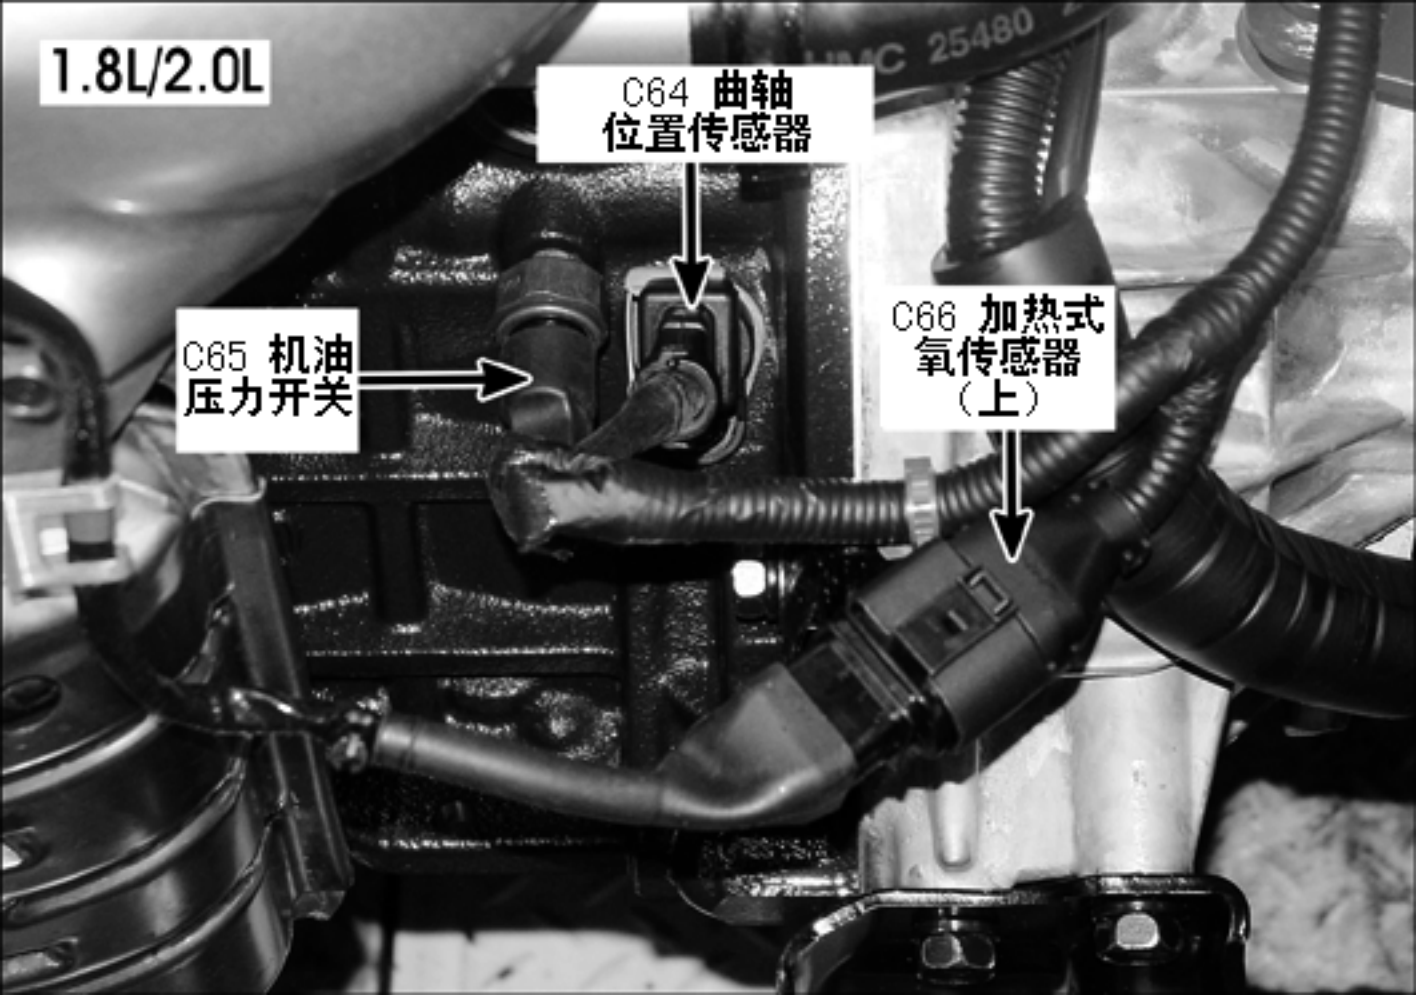
C64 曲轴  
位置传感器

C65 机油  
压力开关

C66 加热式  
氧传感器  
(上)

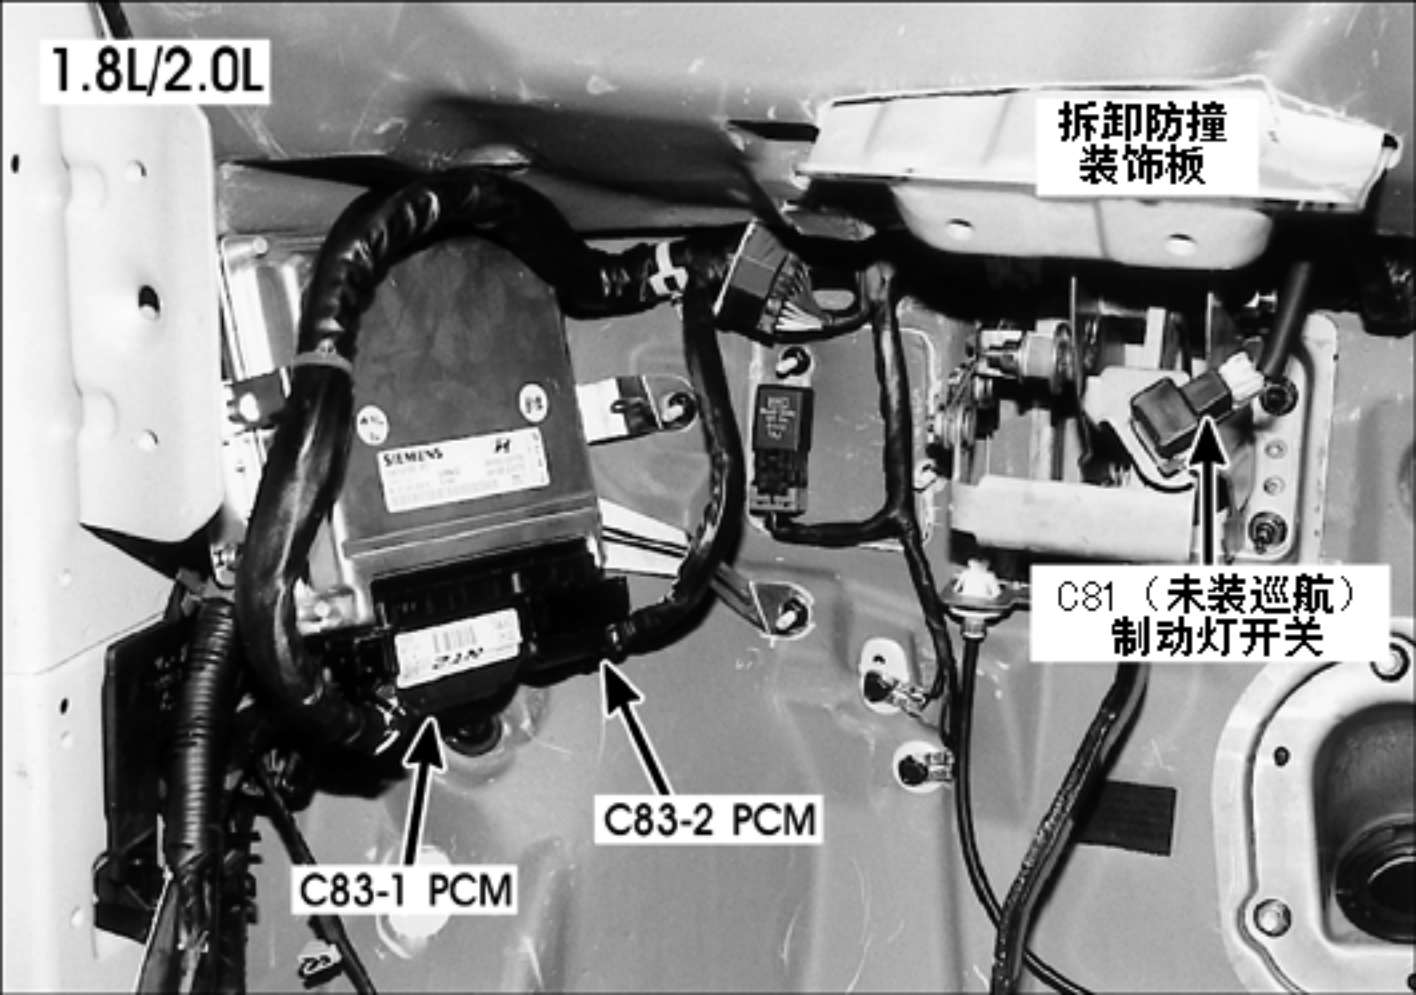
C81 (未装巡航)  
制动灯开关

C83-2 PCM

C83-1 PCM

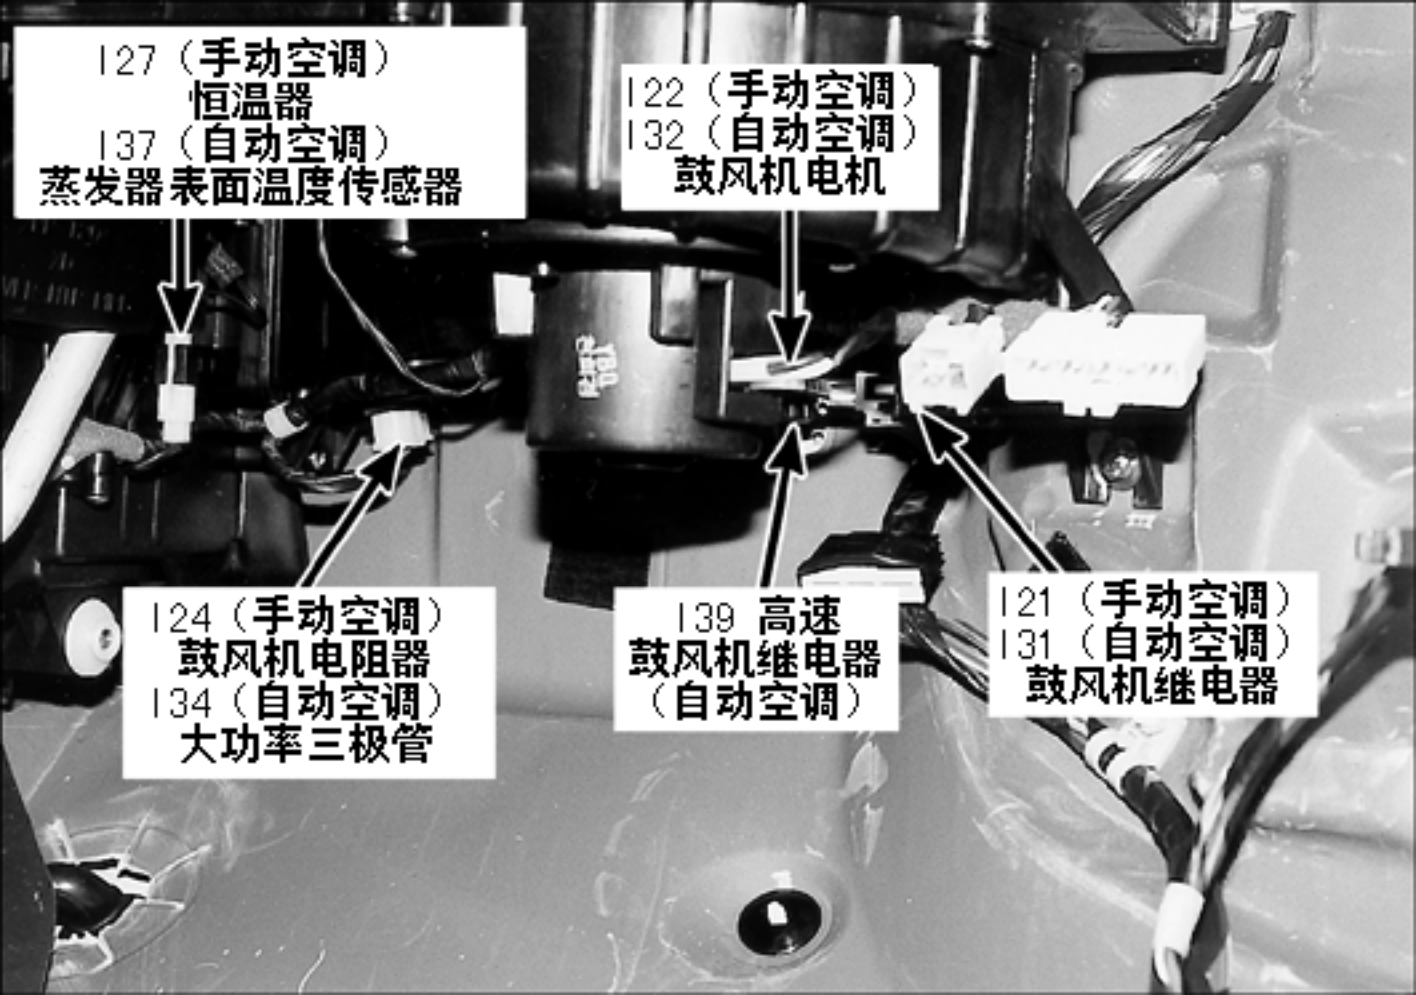
127 (手动空调)  
恒温器  
137 (自动空调)  
蒸发器表面温度传感器

122 (手动空调)  
132 (自动空调)  
鼓风机电机

124 (手动空调)  
鼓风机电阻器  
134 (自动空调)  
大功率三极管

139 高速  
鼓风机继电器  
(自动空调)

121 (手动空调)  
131 (自动空调)  
鼓风机继电器

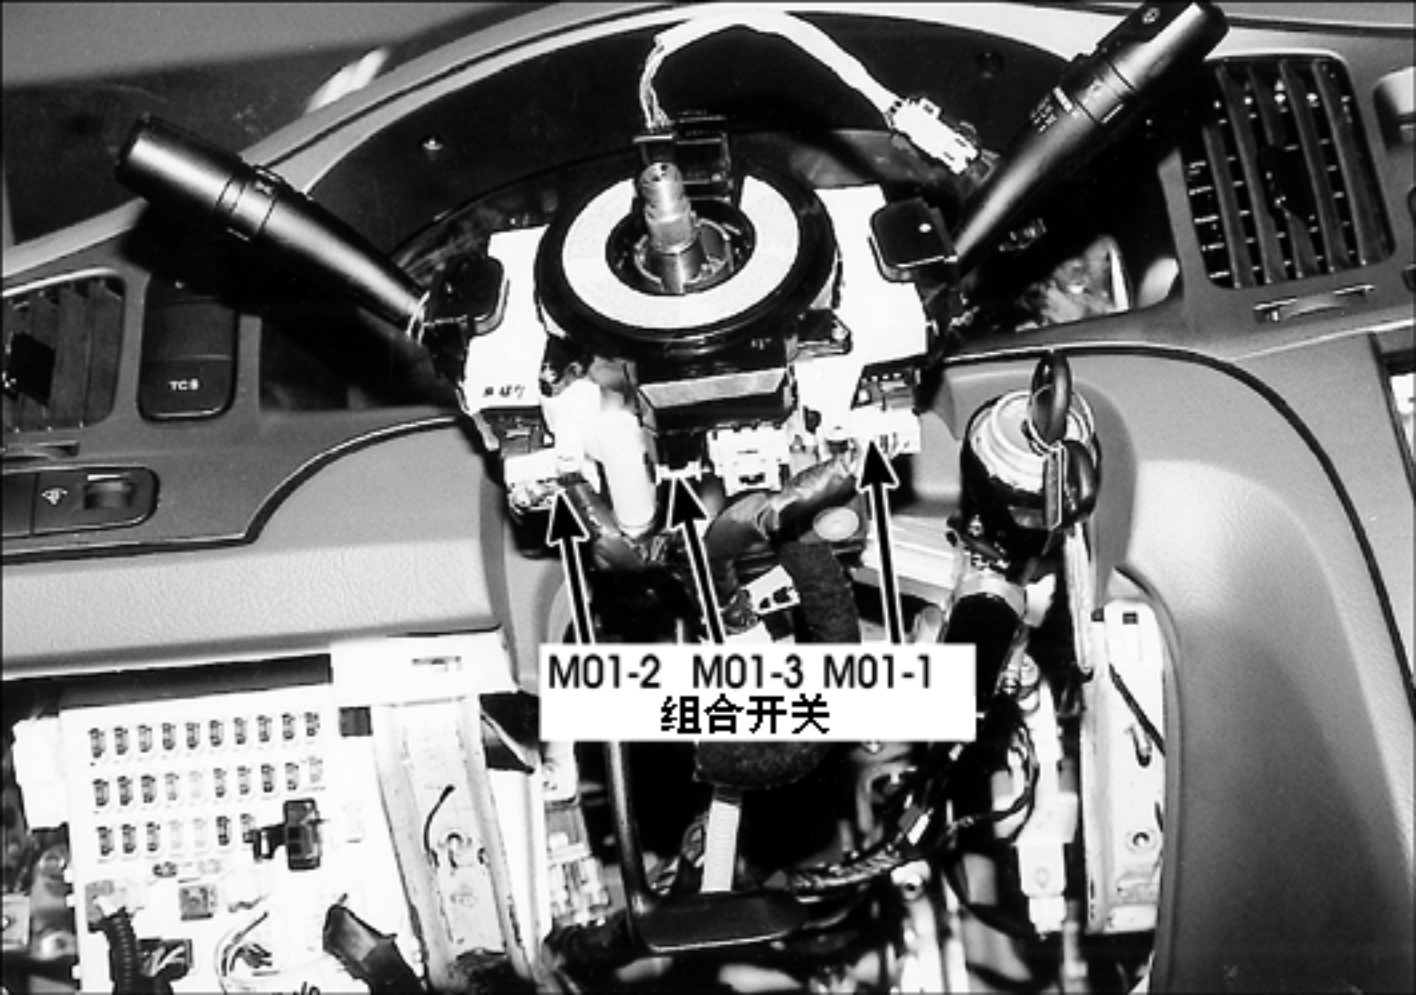
M01-2 M01-3 M01-1  
组合开关

M02  
杂物箱灯

M03-1  
杂物箱灯开关 (+)

M03-2  
杂物箱灯开关 (-)

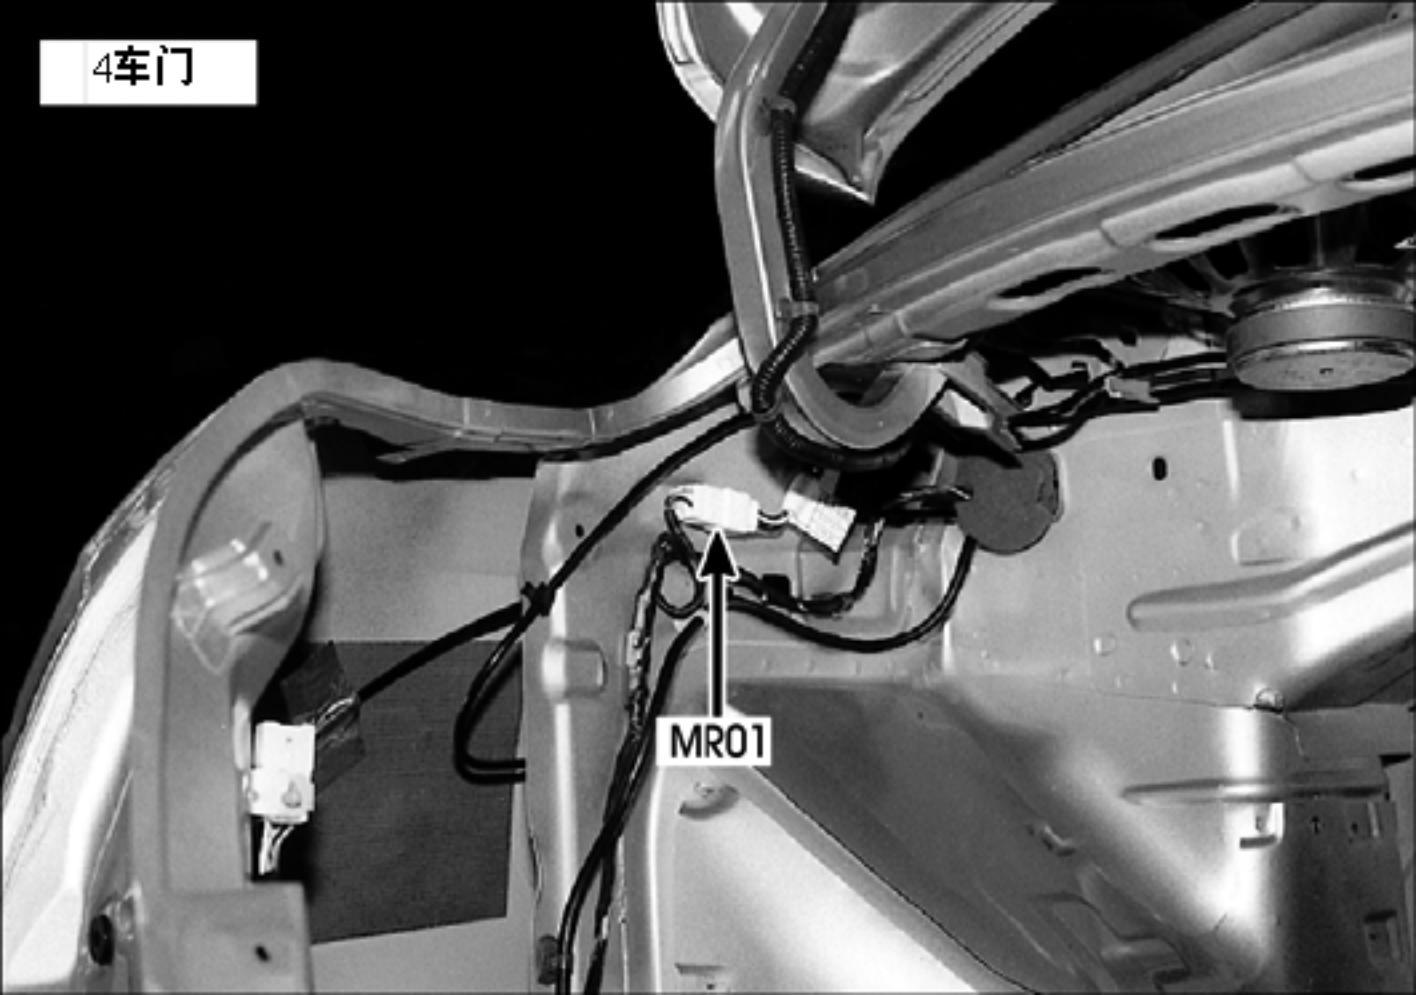
MR01

The image shows the internal components of a car door, likely the driver's side. It features a complex arrangement of wires, a door latch, and various mechanical parts. A white arrow points to a specific electrical connector labeled 'MR01'. The connector is a small, white, rectangular component with a circular base, attached to a bundle of black wires. The surrounding area is metallic and shows signs of wear and tear.
