Connector: **C0047L**

**CONNECTOR HOUSING NOT SERVICEABLE**

Description: **Main harness to instrument panel harness**

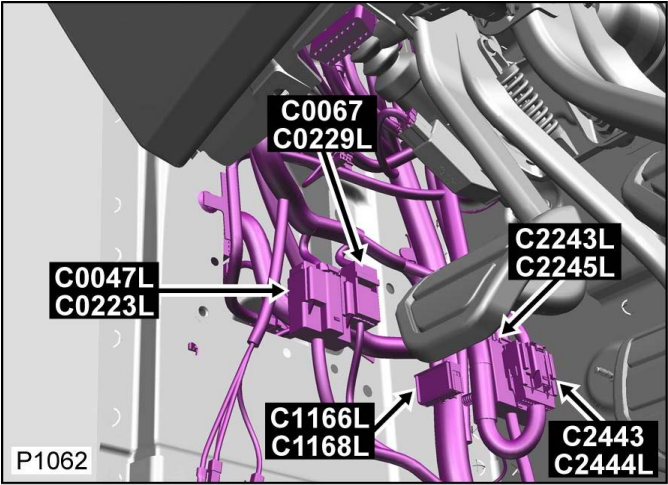
Part No.: **YPC911790**

Colour: **LIGHT GREY**

Cavities: **12WY**

Harness: **CABIN HARNESS**

Location: **Left A-pillar**
