Connector: **C0082L**

Harness: **FACIA COMPOSITE HARNESS**

Description: **Clockspring**

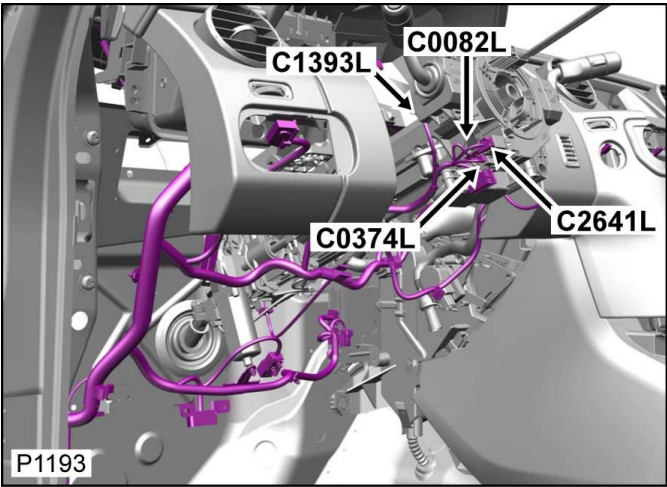
**CONNECTOR HOUSING NOT SERVICEABLE**

Part No.: **YPC800520**

Colour: **BLACK**

Cavities: **8WY**

Location: **Behind steering column cowl**

Wire Chart

| CAV | CSA | COL | CCT | DESTN |
| 2 | 0.35D | WS | 139L | C0230 |
| 3 | 0.35D | NG | 139L | C2238L |
| 4 | 0.35D | SR | 922L | C2819L |
| 4 | 0.35D | SR | 125L | C2515L |
| 5 | 0.35D | WS | 139L | C0581 |
| 6 | 0.35D | BK | 139L | S/JOINT SJ663L |
| 7 | 0.35D | BK | 124L | C2819L |
| 7 | 0.35D | SB | 125L | C2515L |
| 8 | 0.35D | GB | 139L | C0582 |
