Connector: **C0192L**

Harness: **BATTERY POSITIVE PETROL V6 LHD  
HARNESS**

Description: **Relay-Transit**

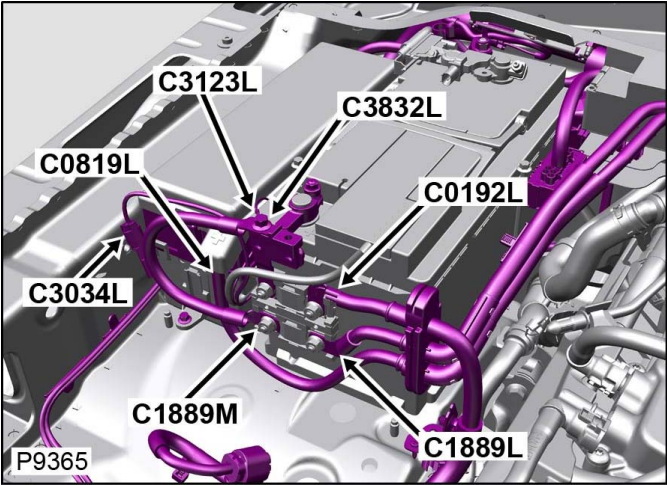
Location: **RH side of engine compartment**

Qualifier: **LHD condition illustrated**
