Body Electrical System > Fuel Filler Door > Components and Components Location**Component Location**

Body Electrical System > Fuel Filler Door > Fuel Filler Door Release Actuator > Repair procedures

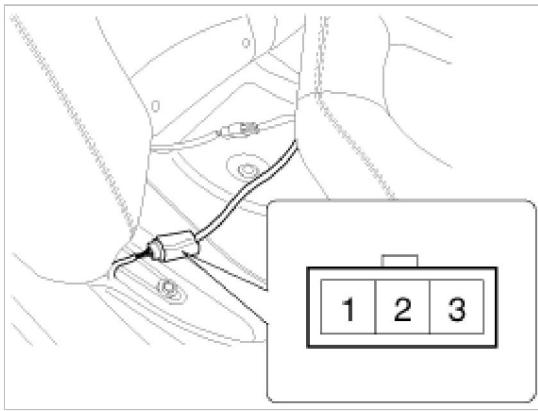
Standard value (Bench / Split)

Cushion : $1.53 \Omega \pm 10\% / 4.05 \Omega \pm 10\%$

Back : $1.35 \Omega \pm 10\%$

Set : $2.88 \Omega \pm 10\%$

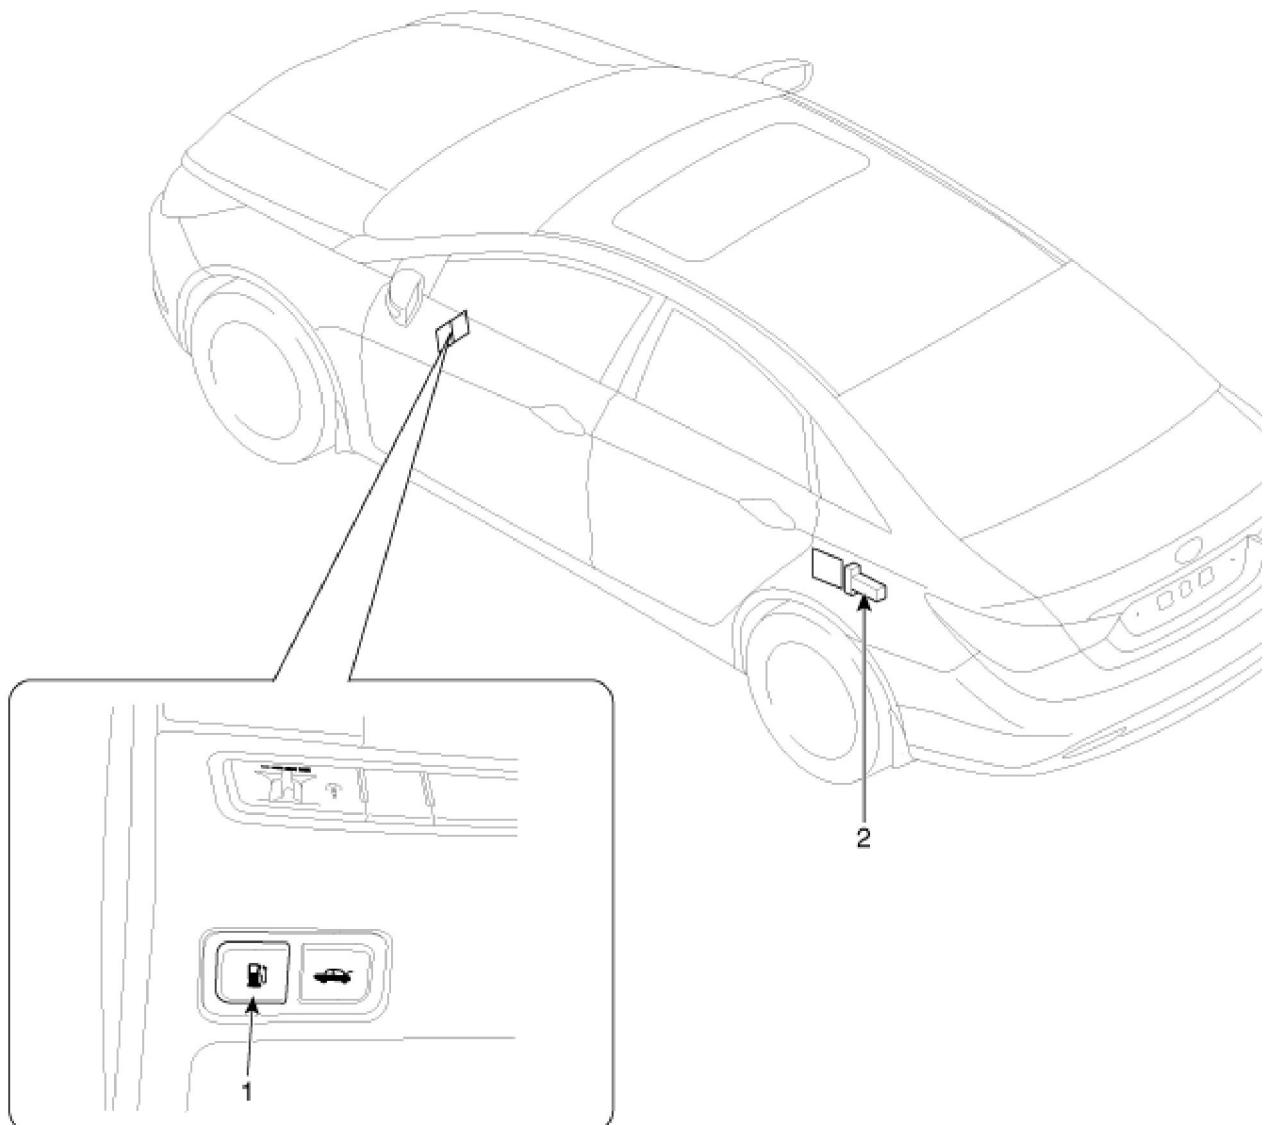
1. Fuel filler door open switch

2. Fuel filler door release actuator

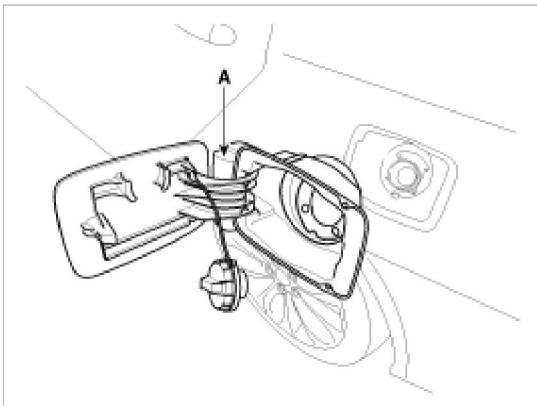
1. Remove the trunk room left side trim.
(Refer to the BD group - "Interior trim")
2. Open the fuel filler door and remove the housing (A).

Do not reuse the fuel filler door housing.

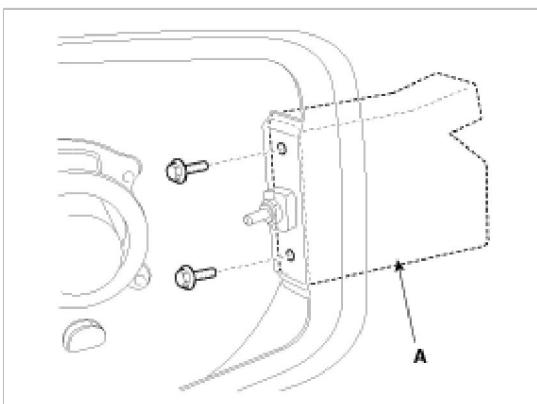
3. Remove the fuel filler door release actuator (A) after loosening the mounting bolts.

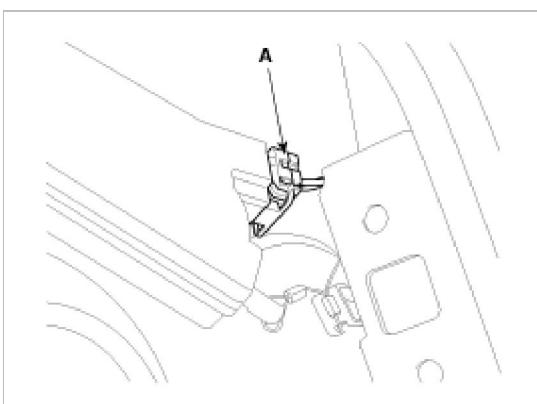
4. Disconnect the release actuator connector (A).

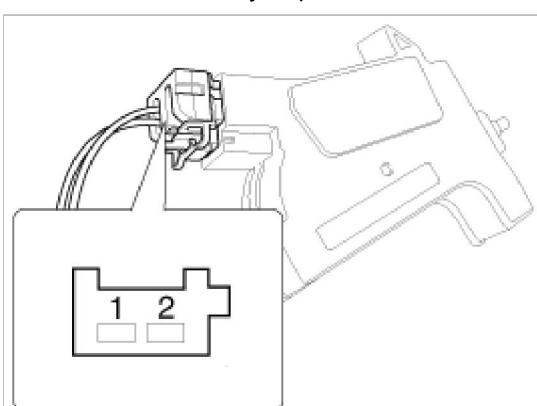
5. Check for continuity between terminal No.1 and No.2.
If there is no continuity, replace the fuel filler door opener.
